TECHNICAL INSPECTION REPORT

U.S.S. CARLISLE (APA. 69)

TEST ABLE

OPERATION CROSSROADS

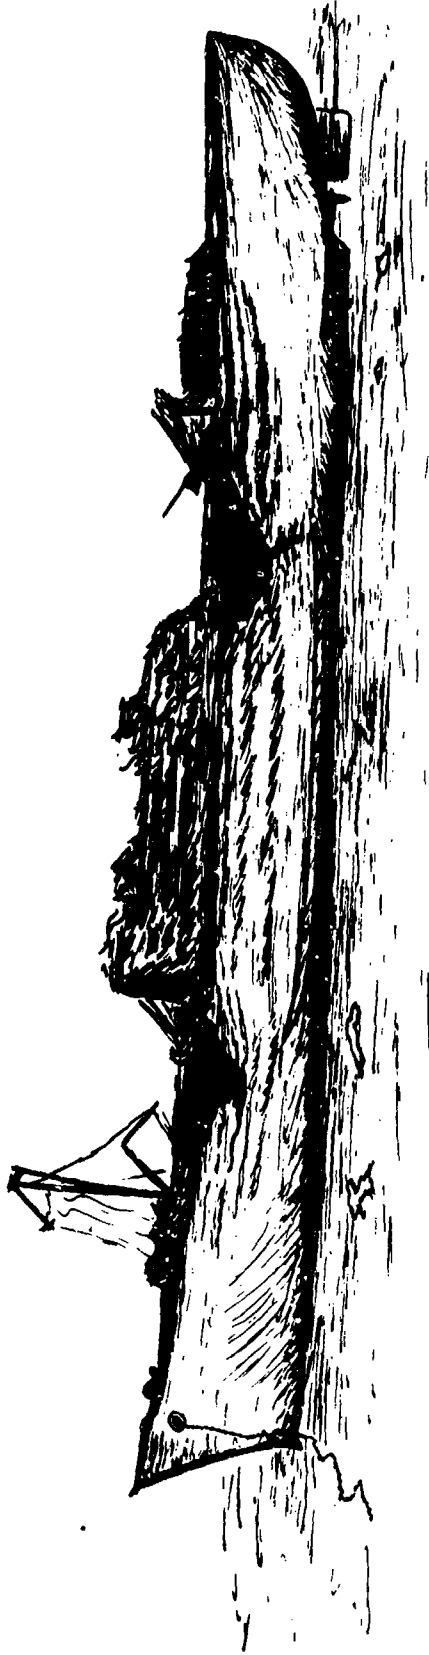
PORT SIDE

RECONSTRUCTED FROM DIVERS REPORTS

The port side of the CARLISLE which was the side exposed to the air burst was damaged extensively. Two large holes were blown in the port shell plating and there was a general displacement to starboard of topside structure.

From the bcwto frame 20 port there is little evidence of damage. From frame 20 to 27, slight transverse buckles are apparent in the upper deck plating. From frame 27 to frame 60, the port side shell plating from a few feet above the turn of the bilge to the upper deck is blown into the ship. Below this hole, the shell

plating is dished between frames but is without visible rupture. At frame 30 above this hole, the upper deck has been ripped loose from the shell plating and doubled back on itself until the set of bitts on the deck edge are overhead and upside down. The deck is pushed up several feet on the port side and is generally buckled to the centerline. Near the foremast, there is a tear in the upper deck which runs inboard 6 or 8 feet from the port deck edge.

A second and similar break in the port shell plating exists between frames 95 and 120. Between the two large breaks and aft to about frame 130, considerable horizontal buckling of the side is present but with no ruptures being noticed by the divers. From frame 130 aft there is no visible damage.

The CARLISLE was found in about 170 feet of water and with a small list of about 5 degrees to port. The underwater photographs (photo on Pages 14 thru 21) show none of the major structural damage reported by the divers. The sketch on Page 22 has been sketched from their reports.
